## Gearbox Maintenance Report

| Customer: | Anhui Tongling Conch Cement Co., Ltd. | Maintenance Company: | Welter Nanjing works |

| Model | KMP710 | Serial Number | 425-408-019-2-01 | Power | 3298KW |
| Speed Ratio | 39.67 | Total Weight (kg) | | Manufacturer | Flender |

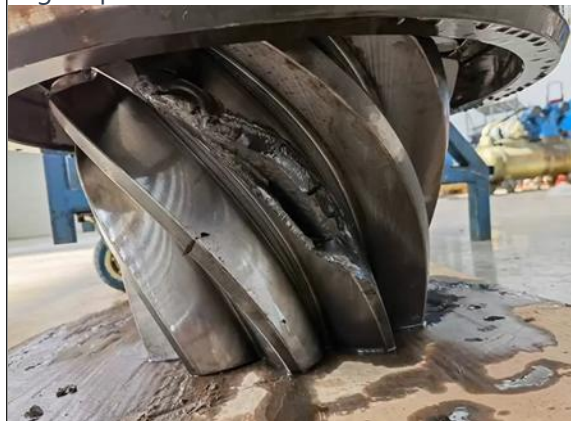
1. One tooth of the umbrella gear shaft in the reducer is broken.
2. Severe wear on the inner tooth sleeve and the vertical shaft tooth surface, with individual teeth broken.

High-Speed Shaft 100 - Tooth surface breakage

| No. | Item | Content | Material or brand | Unit | Qty | Description of Old Part Damage or Wear | Remark |
|---|---|---|---|---|---|--|---|
| 1 | High-Speed Shaft | 100 | - | Pieces | 1 | Tooth breakage, replacement | - |

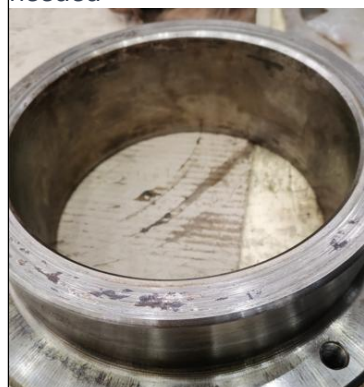
114-T-type Ring - End surface wear, replacement needed

| No. | Item | Content | Material or brand | Unit | Qty | Description of Old Part Damage or Wear | Remark |
|---|---|---|---|---|---|--|---|
| 2 | T-type Ring | 114 | - | Pieces | 1 | End surface wear, replacement | |

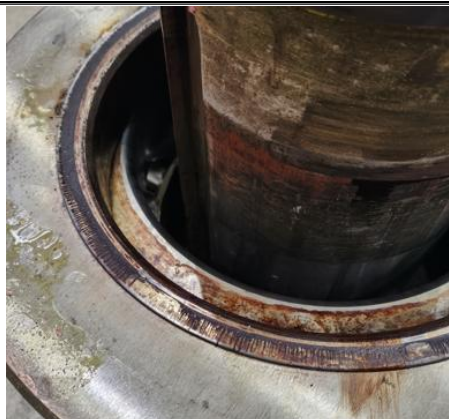
115-Fixed Distance Ring - End surface wear, replacement needed

118-Bearing Adjustment Ring - Wear, replacement needed

| No. | Item | Content | Material or brand | Unit | Qty | Description of Old Part Damage or Wear | Remark |
|---|---|---|---|---|---|--|---|
| 3 | Fixed Distance Ring | 115 | - | Pieces | 1 | End surface wear, replacement | |
| 4 | Bearing Adjustment Ring | 118 | - | Pieces | 1 | Old ring does not meet assembly requirements | |

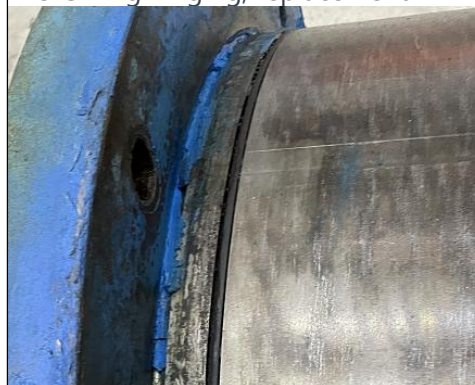
124 - O-ring - Aging, replacement

| No. | Item | Content | Material or brand | Unit | Qty | Description of Old Part Damage or Wear | Remark |
|---|---|---|---|---|---|--|---|
| 7 | O-ring | 124 | - | meters | 3 | Aging, replacement | |

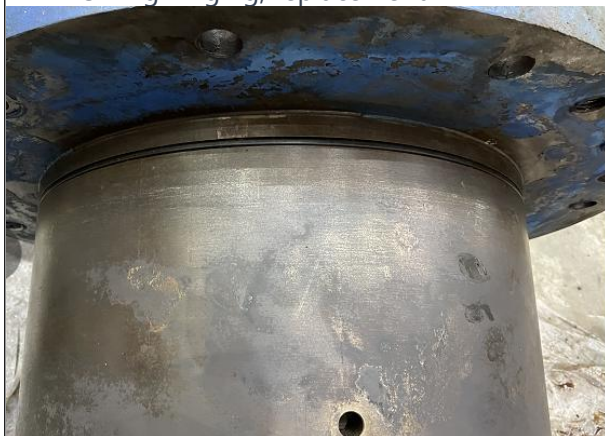
125 Spacer Ring - End surface wear, needs repair before use

| 8 | Spacer Ring | 125 | - | Pieces | 1 | End surface wear, needs repair | |

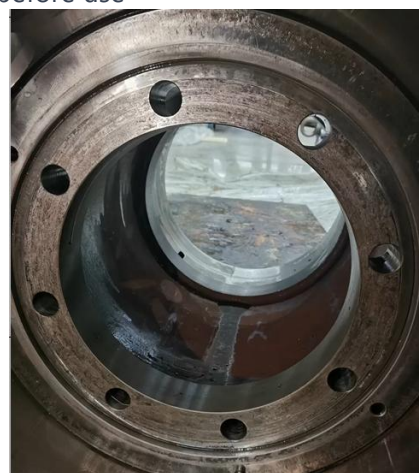
128 Adjustment Pad - For adjusting bevel gears

| 9 | Adjustment Pad | 128 | - | Pieces | 2 | For adjustment | |

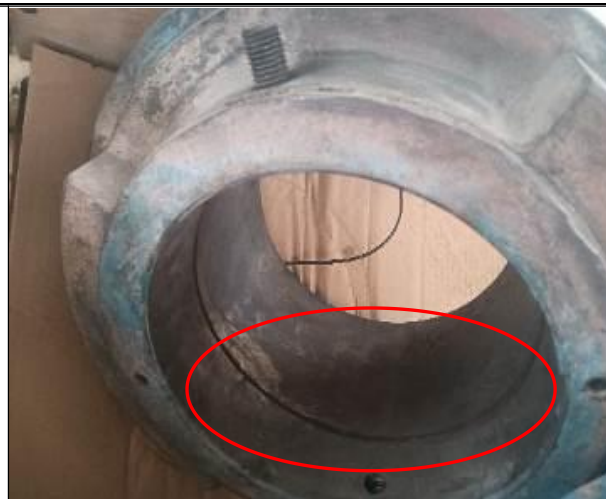
136 - O-ring - Aging, replacement

| 11 | O-ring | 136 | - | meters | 4 | Aging, replacement | |

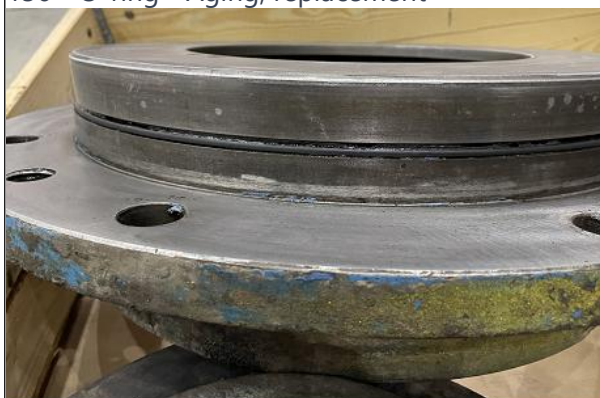
150 Bearing - Wear, scratches

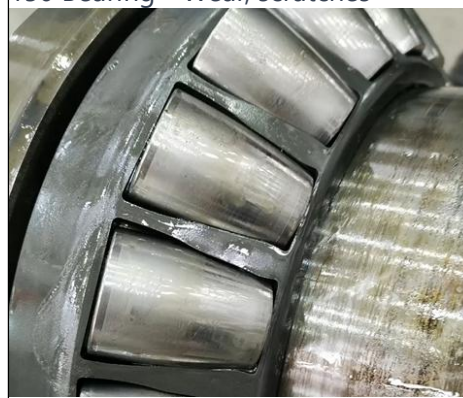
151 Bearing - Foreign object entry, needs dismantling, replacement needed

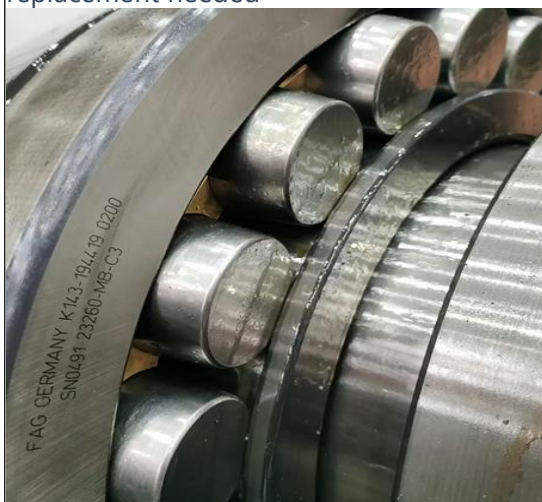
152 Bearing - Wear, scratches

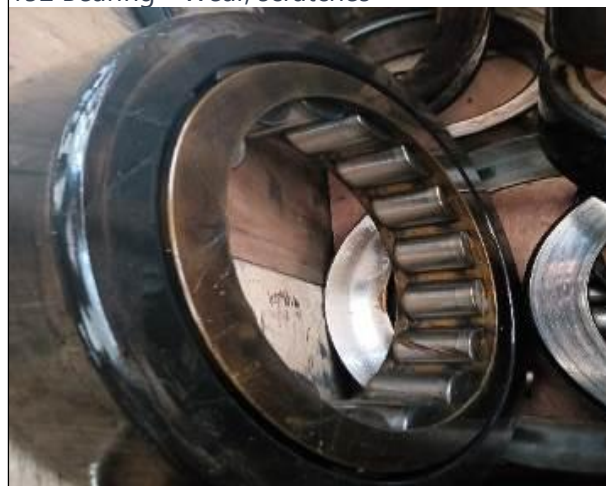
251 Bearing - Obvious scratches on rolling elements

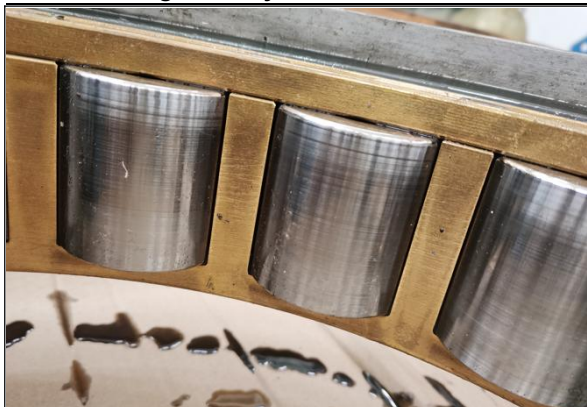
7. Breakage of the M64 bolt on the grinding disc, requiring complete removal. After lifting the reducer grinding disc, all thrust pads are severely worn, with no traces of lubricating oil on the surface. It can be determined that the high-pressure lubrication system is blocked. The customer needs to check their own high-pressure oil supply system, such as checking whether the high-pressure pipe is blocked, pump pressure, and filter status, lubricating oil status, otherwise, the same problem may occur.

253 Thrust Pad - Severe wear, needs casting repair

| 16 | Thrust Pad | 253 | - | Pieces | 12 | Severe scratches, needs repair | |

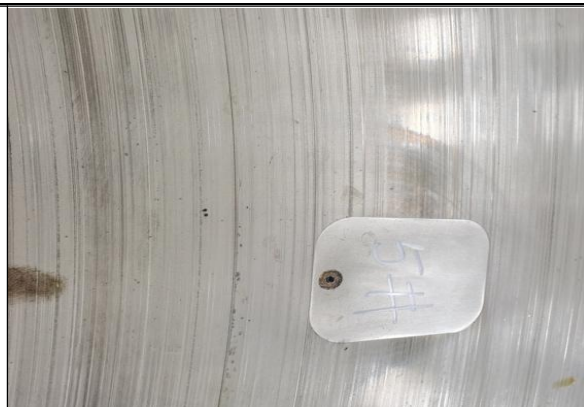
5. Wear on the upper part of the planetary carrier pin hole and wear on the 251 bearing end face positioning surface.
6. Damage to the internal bearing snap ring of the planetary wheel, with individual rolling elements tilting. Breakage of the retaining frame, poor operating condition of the planetary carrier. There are traces of previous repairs and wear on the bearing adjustment ring and the planetary carrier.

350 Planetary Wheel Bearing - Retaining frame breakage, tilting of rolling elements

| 17 | Bearing | 24164-BE-XL-C3 | - | Pieces | 3 | Retaining frame breakage, tilting of rolling elements, replacement needed | |

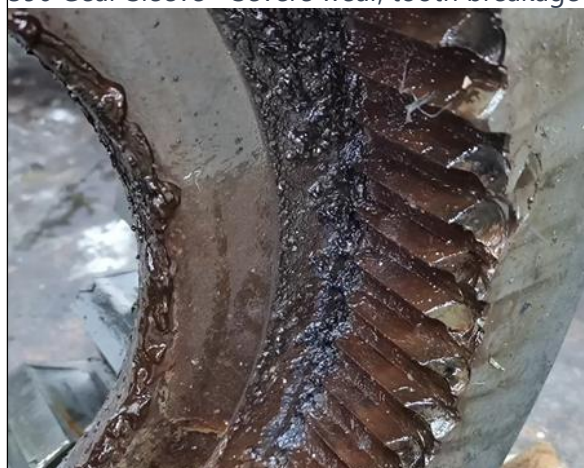
400 Intermediate Shaft - Severe wear, tooth breakage

| 19 | Intermediate Shaft | 400 | - | Pieces | 1 | Severe wear and tooth breakage, replacement needed | |

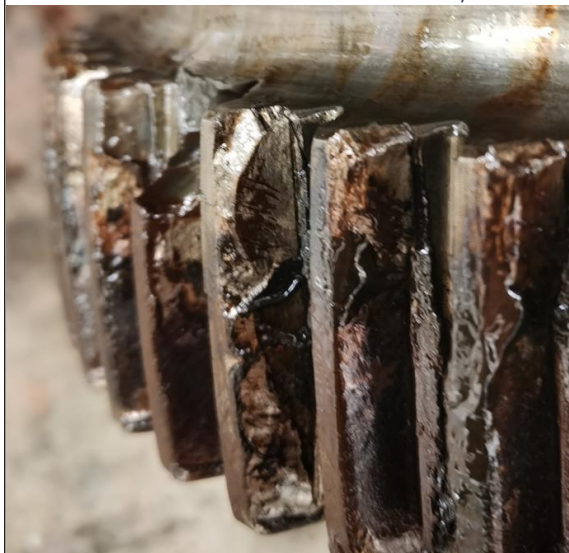
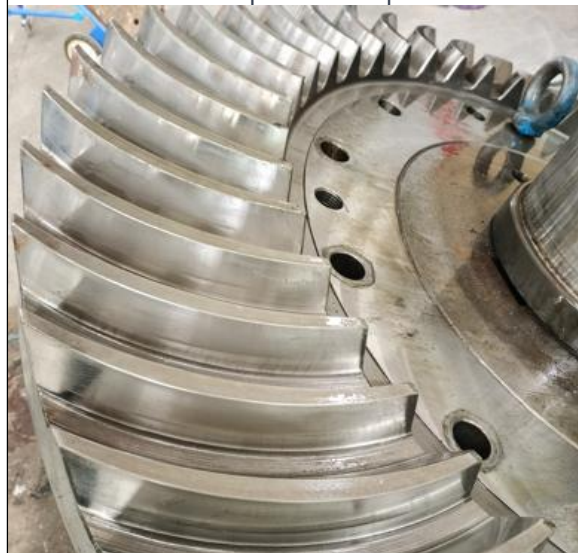
402 Bevel Gear - Replacement paired with 100

| 20 | Umbrella Gear | 402 | - | Pieces | 1 | Replacement as a pair with 100 | |

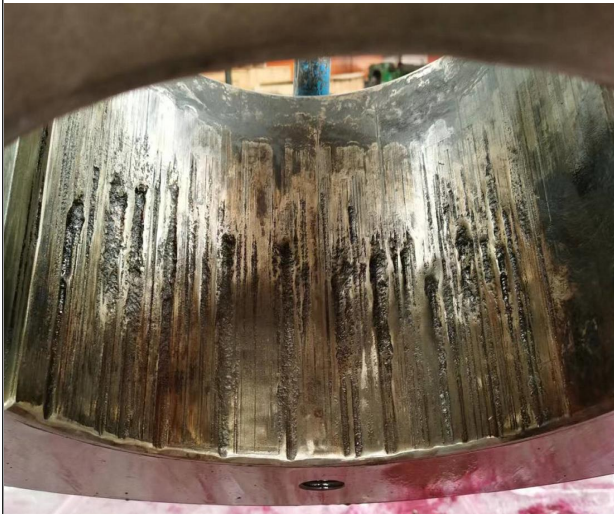
3. Wear on the sun gear ball crown, requiring a complete set replacement.
4. Serious wear on the hub hole of the vertical shaft, with a depth of about 5-6mm. Determined to be caused by previous hole repair, with dimensions exceeding tolerances, resulting in loose fit and inability to provide positioning and torque transmission functions.

404 Hub - Severe repair marks on the hole, significant internal hole damage, depth about 5-6mm

| 21 | Hub | 404 | - | Pieces | 1 | Severe bearing wear, replacement recommended | |

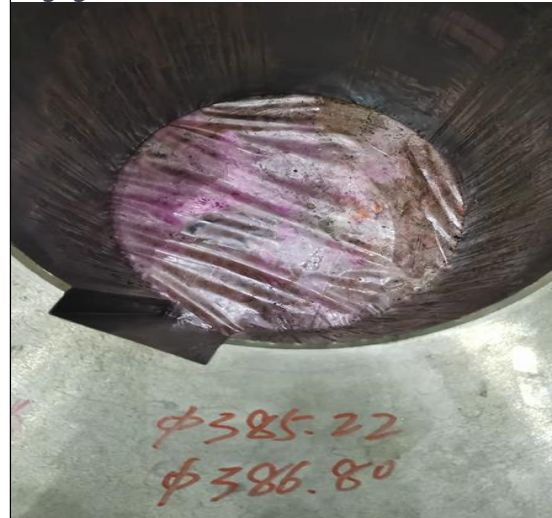
404 Hub - Inner hole designed tolerance is 385H7 (0/+0.057), actual size is (385.22/385.80), serious out-of-roundness. The 400 vertical shaft design size is 385.2/385.24. Continued use without interference will affect alignment and torque transmission, thus affecting bevel gear engagement.

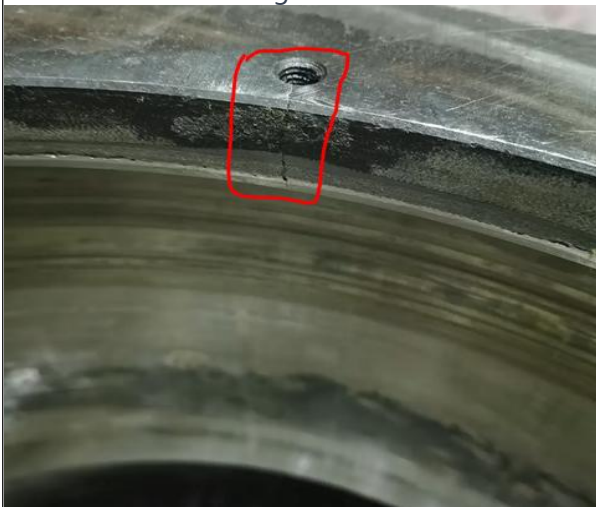
420 Bevel Gear Bearing Sleeve - Bolt crack

| 22 | Umbrella Gear Bearing Sleeve | 420 | - | Pieces | 1 | Cracked, replacement needed | |

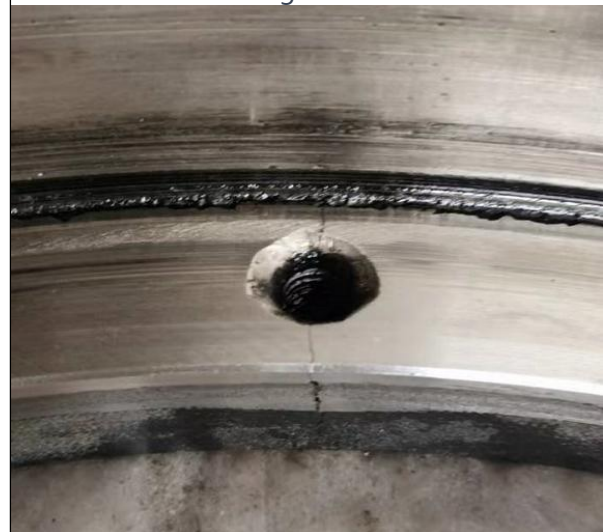
420 Bevel Gear Bearing Sleeve - Bolt crack

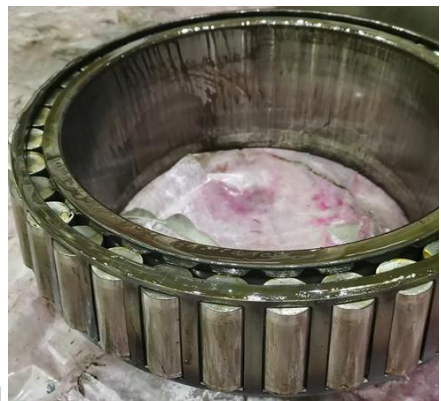
450 Bearing - Foreign object entry, wear, Replacement

needed.

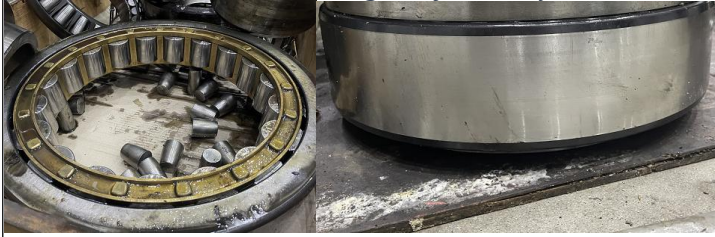
451 Bearing - Scratches, foreign object entry

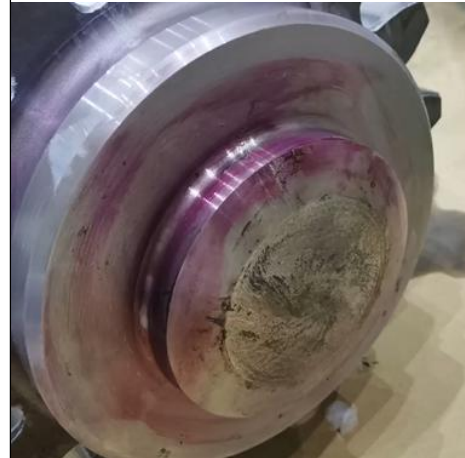
301 Sun Gear - Ball crown wear, replacement needed

| 26 | Sun Gear | 301 | - | Pieces | 1 | Ball crown wear, replacement needed | |

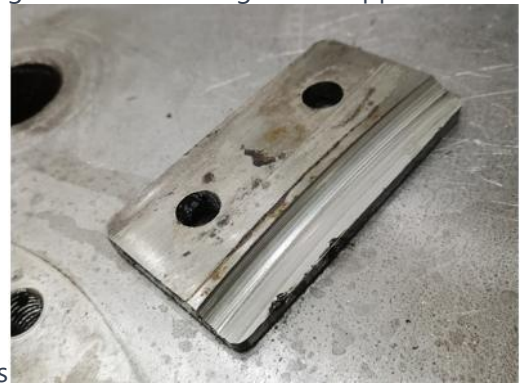
256-251 Bearing Support Block - Severe wear, bearing race, new design has a flange fixing the bearing as a whole through four support

blocks

| 28 | Bearing Support | 256-251 | - | Pieces | 4 | Wear, replacement needed | |

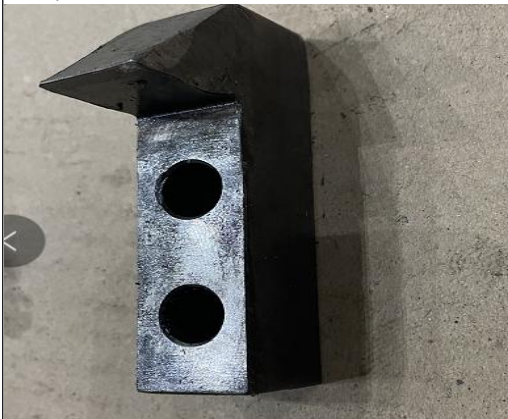
251 Bearing Limit Block - Not in the old design, bearing race, needs addition

| 29 | Bearing Limit Block | 251 | - | Pieces | 2 | Bearing race, needs addition | |

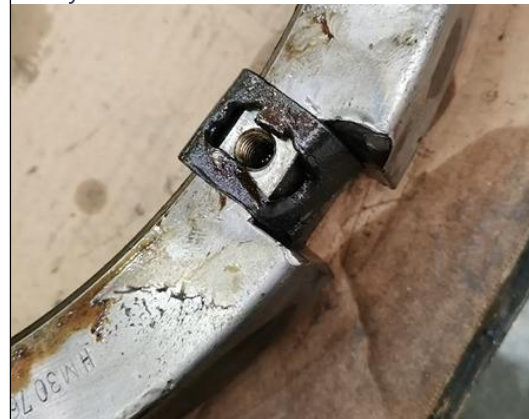
411 Lock Nut Stop Piece - Deformed, needs to be newly made

| 30 | Lock Nut Stop Piece | 411 | - | Pieces | 1 | Damaged, replacement needed | |

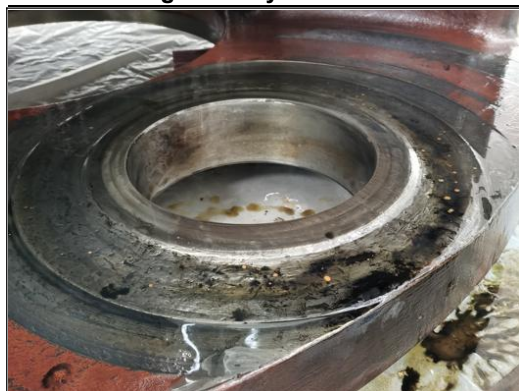
200 Planetary Carrier - Wear on the upper pin hole, out-of-roundness

| 31 | Planetary Carrier | 200 | - | Pieces | 1 | Bearing positioning surface wear, upper pin hole size deviation, can be used after | |

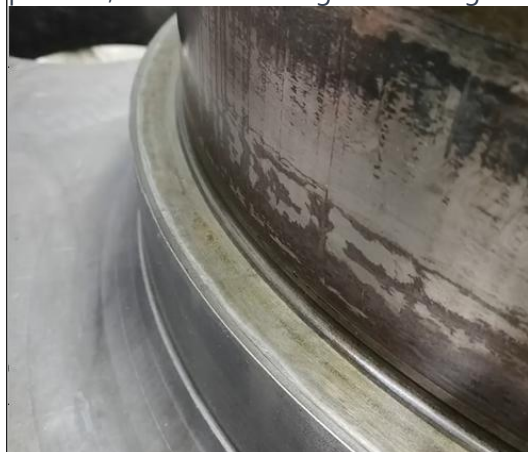
200 Planetary Carrier - Wear at the end of the 251 bearing position, needs machining and adding a locking pin

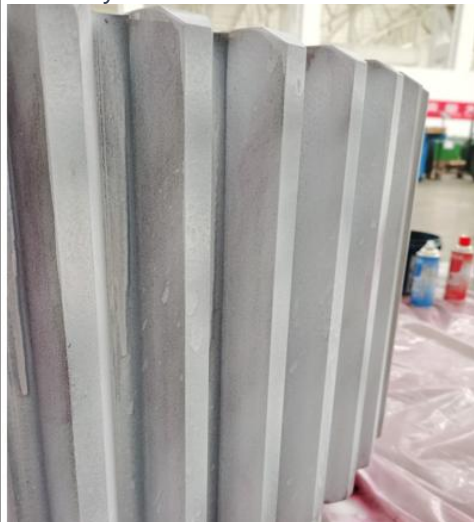
Planetary Wheel Tooth Surface - Normal wear

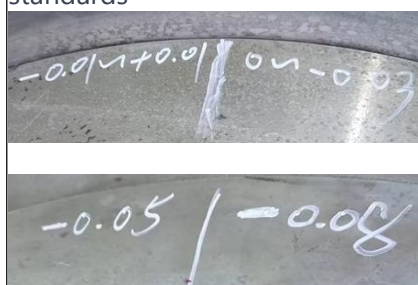
All three Planetary Wheels - Inner hole sizes exceed design standards

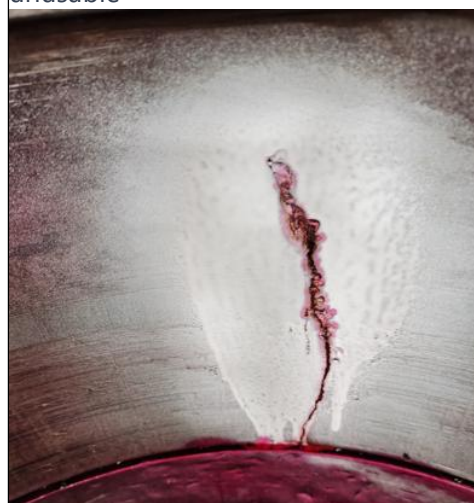
One of the Planetary Wheels - Inner hole crack, unusable

| 32 | Planetary Wheel | 302 | - | Pieces | 3 | Inner hole wear, cracks, replacement needed | |

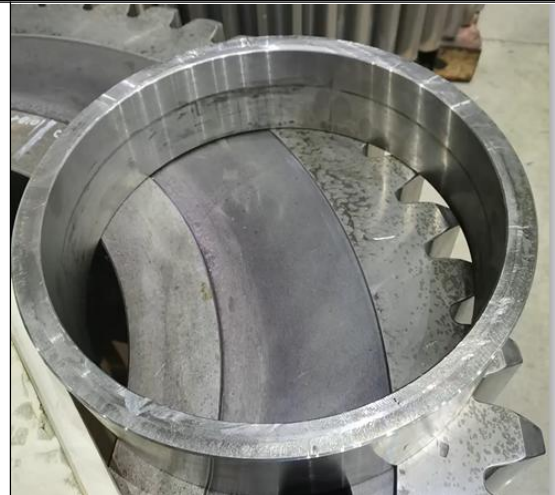
314 Planetary Wheel Bearing Adjustment Ring - Wear, needs remanufacturing

| 33 | Planetary Wheel Bearing Adjustment | 314 | - | Pieces | 3 | Wear, replacement needed | |

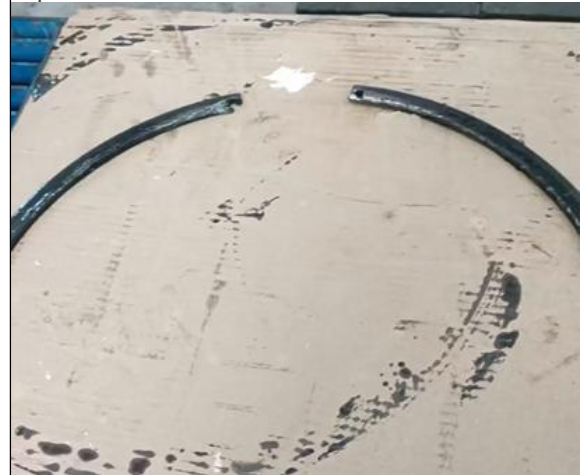
363 Planetary Wheel Bearing Snap Ring - Opening rupture

| 35 | Planetary Wheel Bearing Snap Ring | 363 | - | Pieces | 3 | Damaged, replacement needed | |

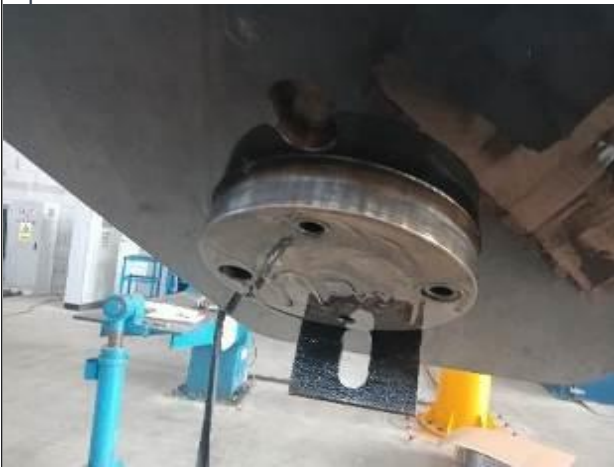
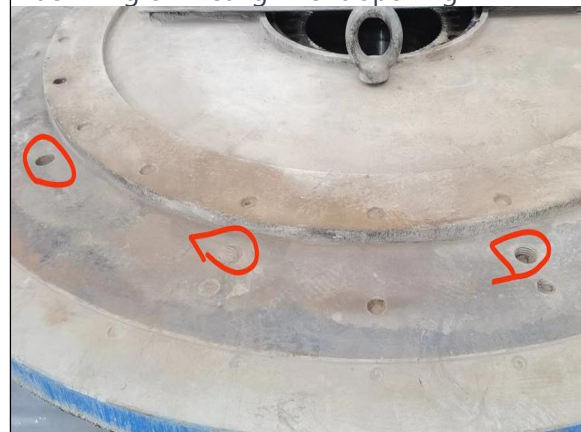
M64 bolt hole on the output flange - Customer cut due to inability to dismantle properly, needs machining or misalignment opening

| 37 | Output Flange M64 Bolt Hole | M64 | - | Pieces | 12 | Bolt misalignment, hole opening | |

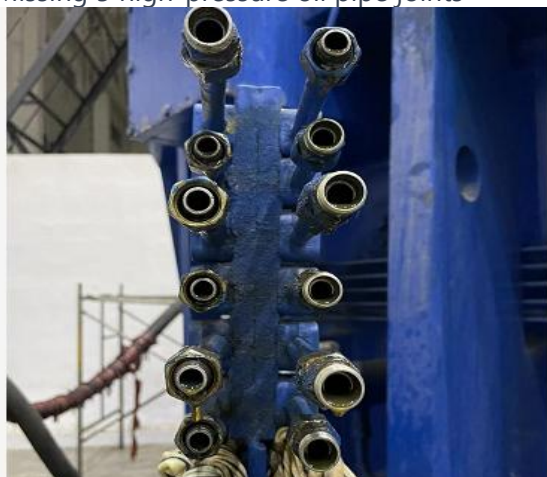
Missing 5 high-pressure oil pipe joints

| 38 | High-Pressure Oil Pipe Joint | M18*1.5 H-type Joint | - | Pieces | 6 | Missing, supplementary for testing | |

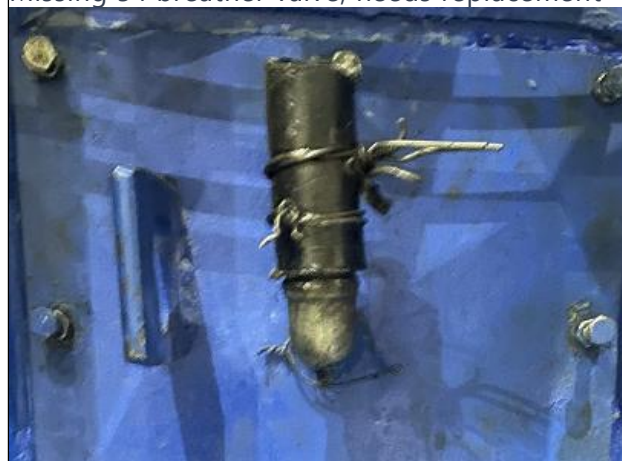
Missing 54 breather valve, needs replacement

| 39 | Breather Valve | 54 | - | Pieces | 1 | Missing, supplementary | |

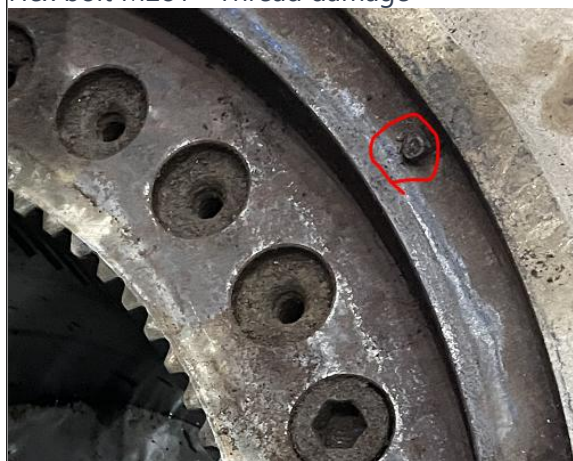
Hex bolt M281 - Thread damage

| 40 | Hex Bolt | 281 | - | Pieces | 18 | Thread damage, replacement needed | |

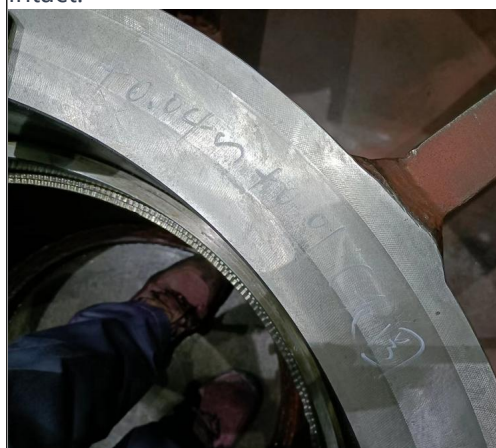
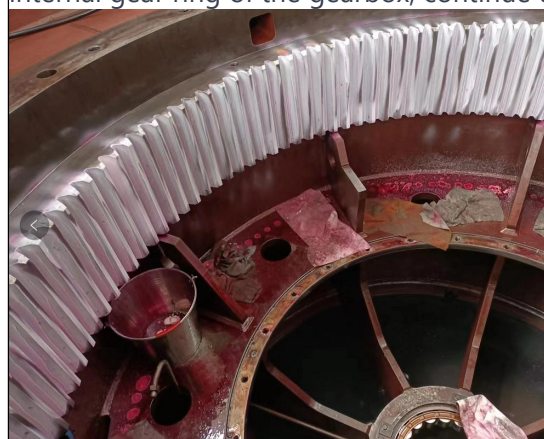
Internal inspection of the 451 bearing hole in the gearbox is intact. After PT testing, no cracks were found in the internal gear ring of the gearbox, continue use.
