Workshop Inspection Report-Mill gearbox 立磨减速机返厂维修服务报告

Customer: Yunnan Kungang Jiahua Cement Building
Materials Co., LTD

Project: Complete System Maintenance

Gearbox: Type: WPU200;; S/N: 16005037/10

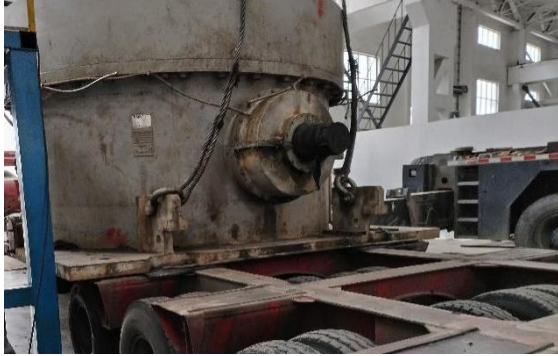
Fig. 1

Without a coupling
There are four lifting lugs
welded to the output
flange.
Prior to the output
flange, there has been a
replacement of welded
maze components.
Internal fastening bolts
are not tightened.
The three-layer gearbox
casing has undergone
welding and replacement
of local components.

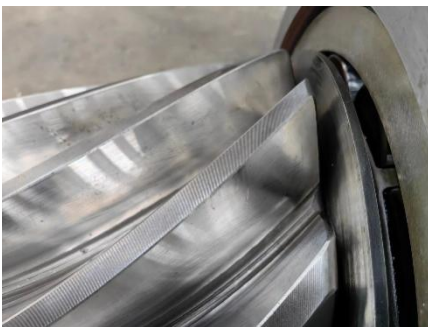
1. Input Shaft

Multiple areas with surface damage on the gear teeth.

There are signs of grinding.

Continued use after manual grinding.

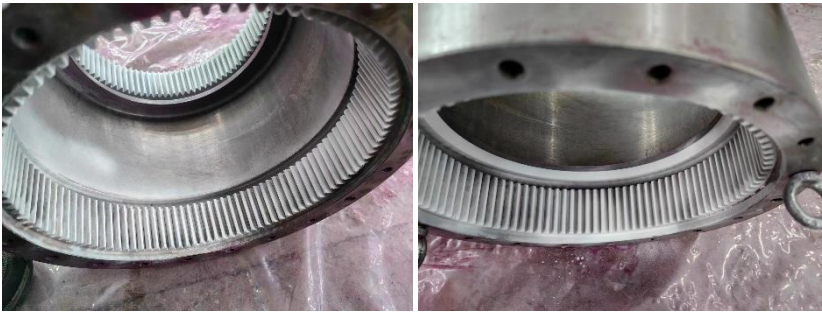
40 Gear Sleeve

Normal wear.
 Continued use is possible.

If the sun gear or input shaft is replaced, this part should be replaced as a set.

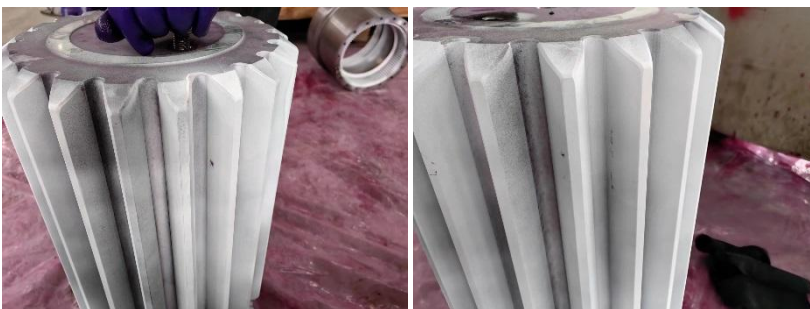
43. Sun Gear

- Pitting
- Peeling
- Replacement required
- Replacement of the entire set (three-piece set)

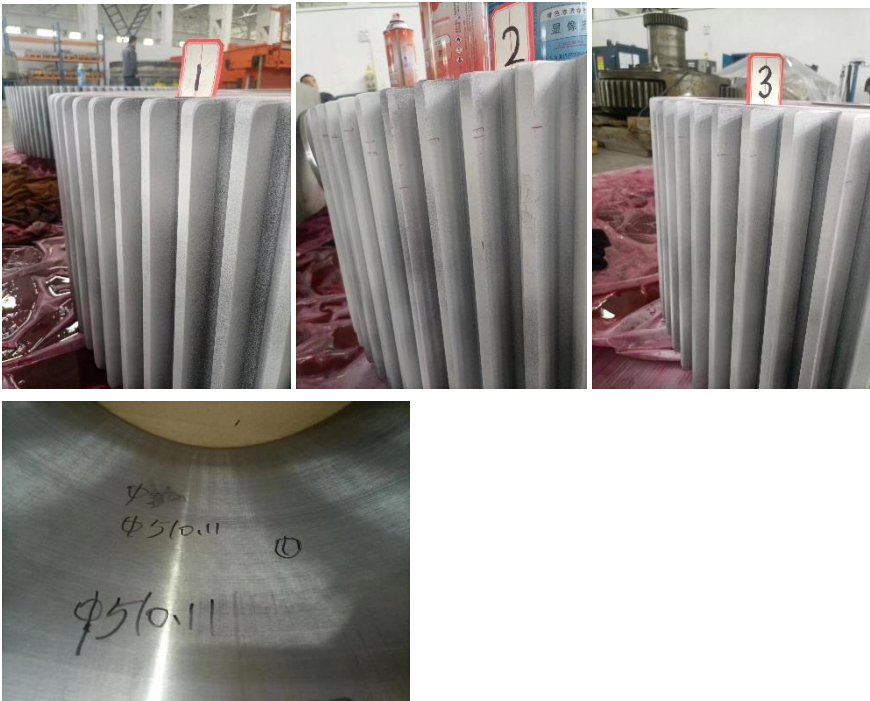
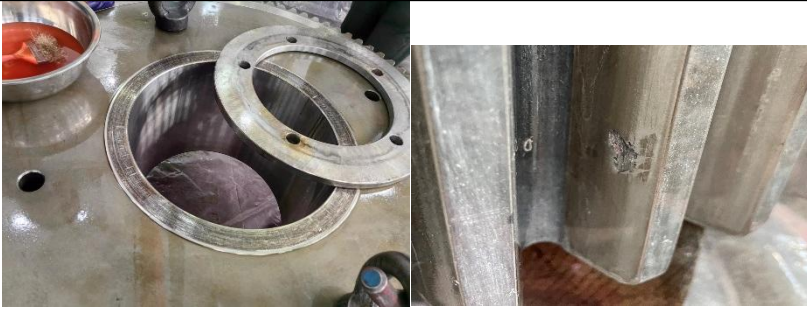
54 planetary gear

1. Fine cracks detected in approximately 2/3 of the teeth on planetary gears 2 and 3 during non-destructive testing (PT).
2. Wear on the inner hole of planetary gear 1, but within acceptable tolerances.
3. Continued use of planetary gear 1.
4. Wear on the

end face of gear 1, which had previously experienced surface loss during disassembly.

5. Peeling observed on planetary gear 2.

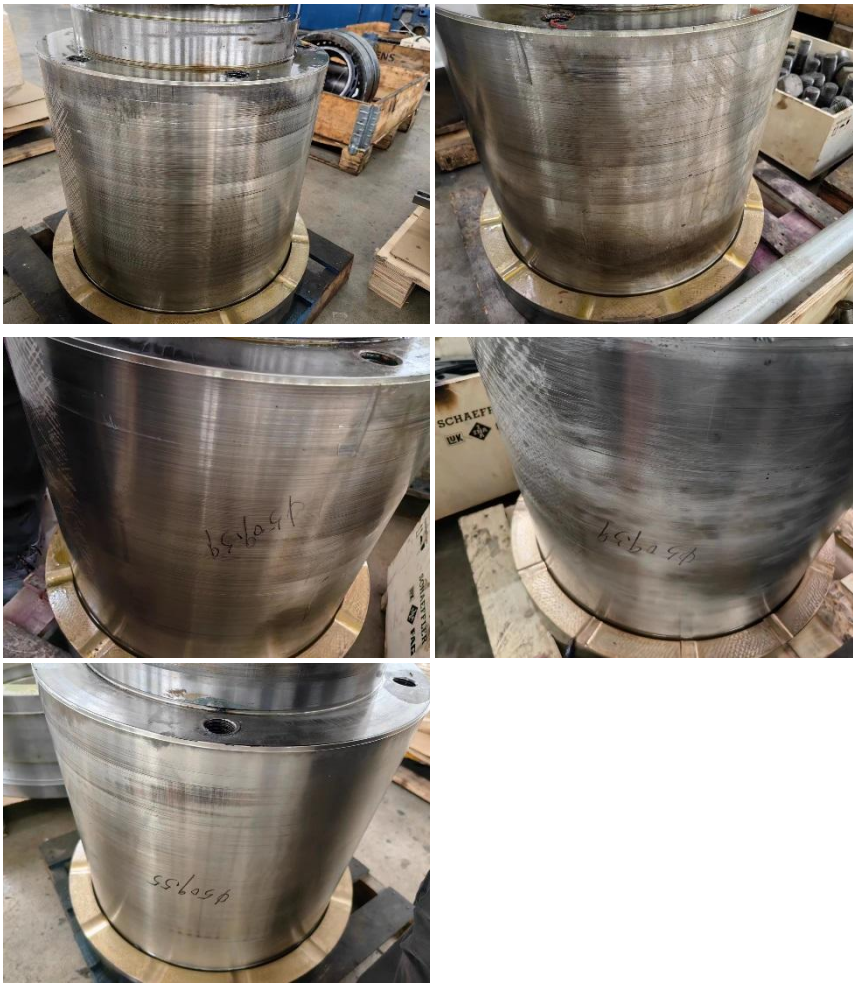
55- Pin

1. Extensive wear on the surface of the shaft (2#3#Pin) made of Babbitt alloy, with significant abrasion in the oil groove. However, the diameter dimensions are within the tolerance range. Poor establishment of the oil film, affecting lubrication.
2. Continued use after repair.
3. Scratched oil line.
4. Manual grinding to remove scratches.

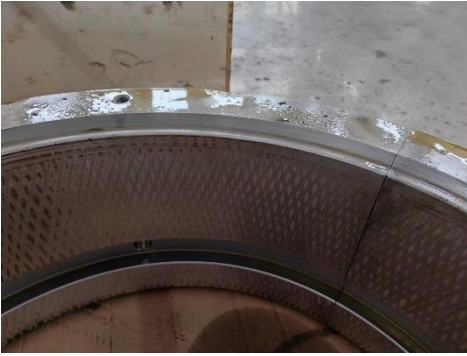
56-Radial bearing

1. Radial bearing has scratches.
2. Continued use after manual grinding.

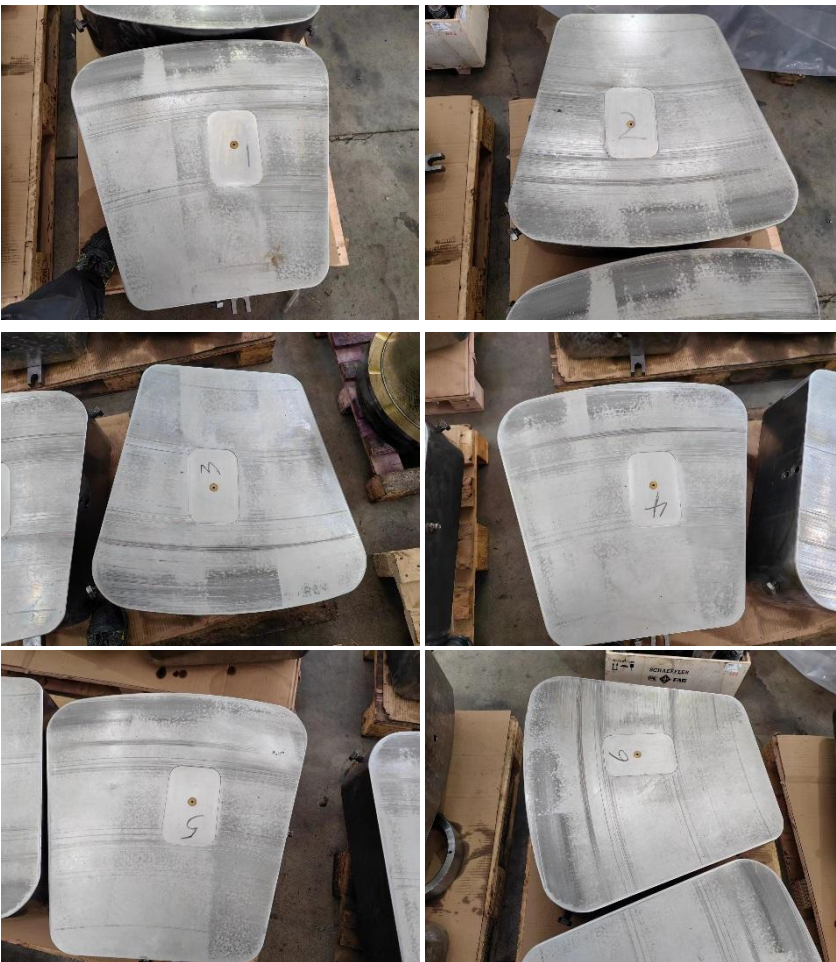
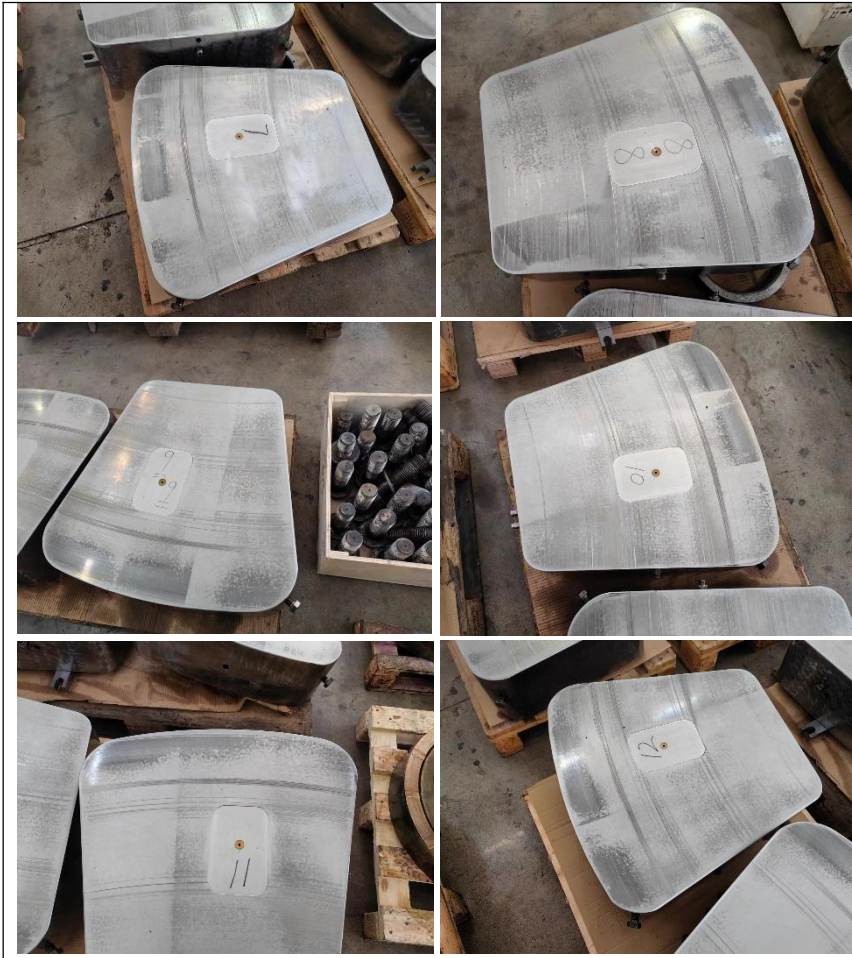
64- Thrust Bearing

1. Radial wear on the thrust bearing, with 3-4 areas experiencing maximum wear width of approximately 8mm, and a noticeable depth.
2. Continued use after repair.
3. The surface has been lathe-turned, cast with Babbitt alloy, coarse-turned on a lathe, and ground to

meet
dimensional
requirements.

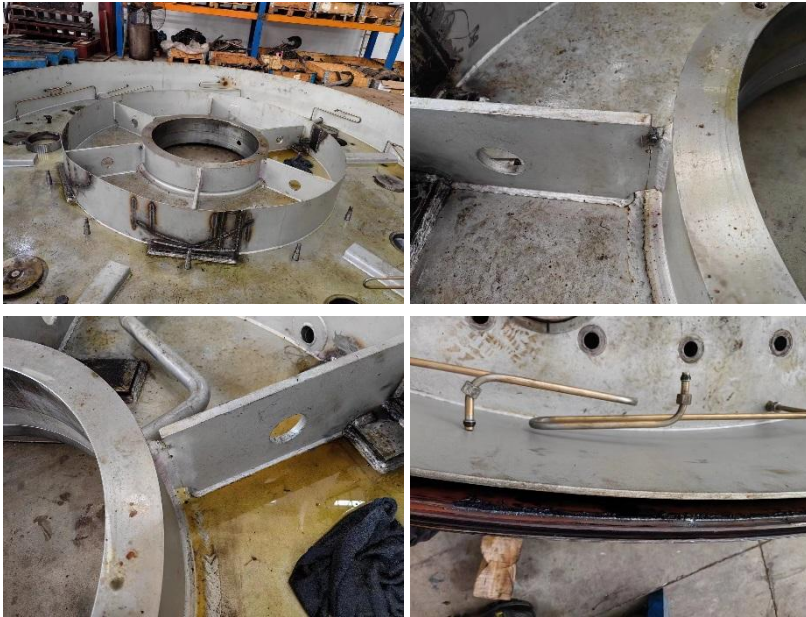
60-Casing

1. Multiple fractures in the rib plates of the gearbox casing, reinforced with welded steel plates at 4 locations, and new cracks have appeared.
2. Deformation and damage to the labyrinth groove of the gearbox casing, with overheating adhesion occurring at the labyrinth joint with the output flange.
3. Replacement is required.

After prolonged use of the reducer, foreign objects entering may cause scratches on the thrust tile surface, scratches on the sun gear pin, scratches on the radial tile, and scratches on various levels of bearings. It is speculated that excessive vibration has caused the third-layer casing to crack. The water content in the lubricating oil exceeds the standard as observed, and there is surface rust on the parts.

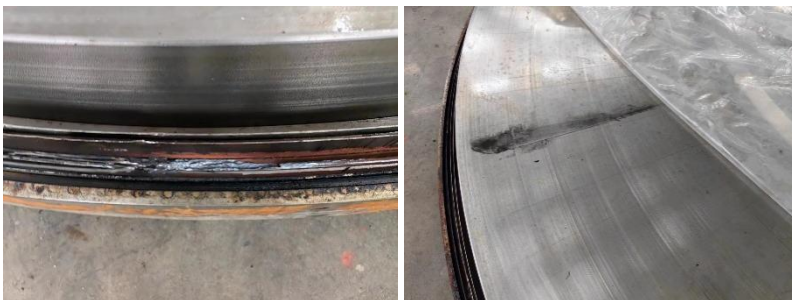
80-Output flange

1. Scratches on the mirror surface of the output flange.
2. Damage to the labyrinth groove of the output flange.

<p>Repairs Needed:</p> <p>Grinding of the mirror surface. Replacement of the labyrinth groove. Lathe-turning for the mirror surface, grinding to meet the drawing requirements for smoothness. Production of the replacement labyrinth part.</p>
<p>22- Oil seal sleeve</p>

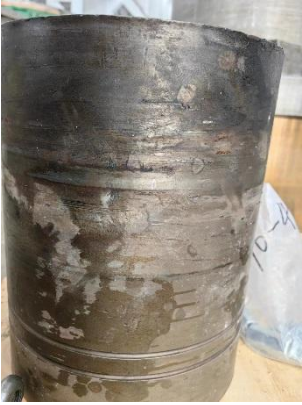
<p>Fault Type:</p> <p>Wear at the sealing position of the oil seal sleeve.</p> <p>Replacement is required.</p>

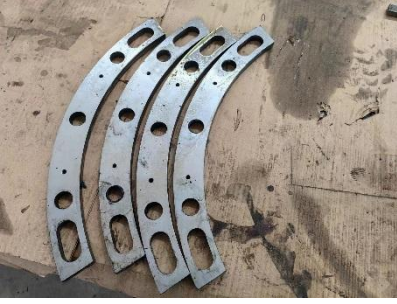
<p>12-Input shaft adjustment shim</p>

<p>Fault Type:</p> <p>Adjustment shim used during input shaft adjustment.</p> <p>Replacement is required</p>
<p>39-Bevel gear adjustment shim</p>

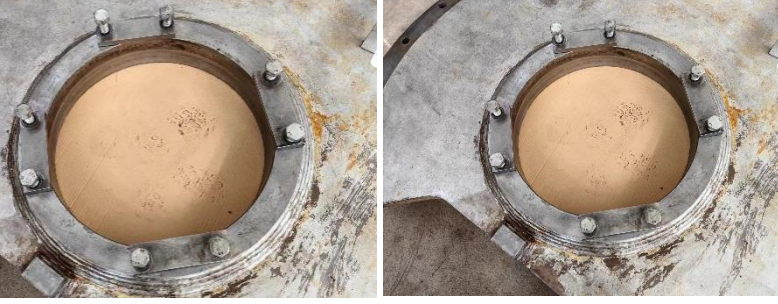
<p>Fault Type: Adjustment shim used during bevel gear adjustment.</p> <p>Replacement is required.</p>
<p>35-Bevel gear cover plate</p>

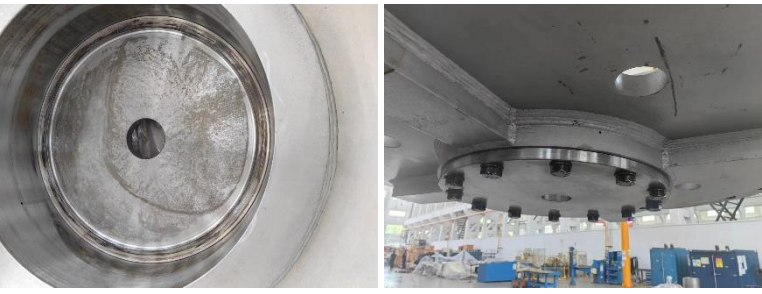
<p>Fault Type: Custom machining of a cover plate is required to meet the adjustment requirements for the axial clearance of the adjusting bevel gear bearing.</p>
