Workshop Inspection Report-KMPS Gearbox

Customer:	Taiwan Cement Corp. (Guigang)
Contact:	Ding jinshan 153 8076 1762
Project:	Complete System Maintenance
Date:	Mar. 27 th . 2023
Engineer:	Wang renjie/Hu shuanglong
Order No.:	WS23105S30207
Gearbox:	Model:KMPS 546; S/N: 4305240-0060-1

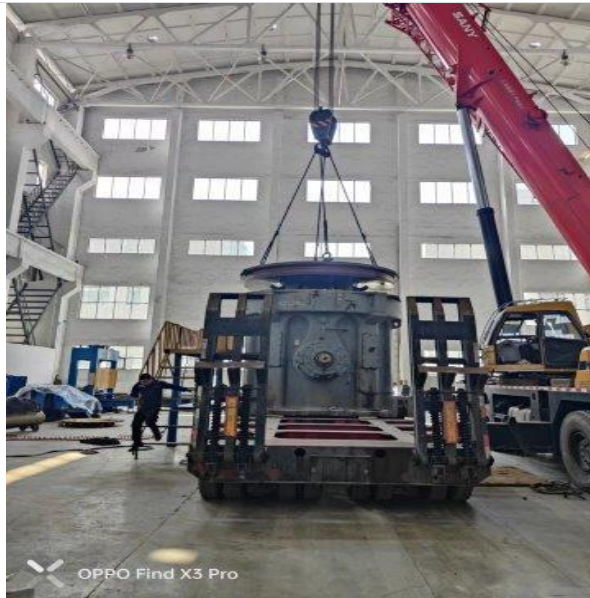
Fig. 1

- Input does not include couplings.
- The lower housing is lacking an oil sight glass.
- The upper housing lacks the return part of the oil supply pipeline.
- The input shaft is equipped with a key strip

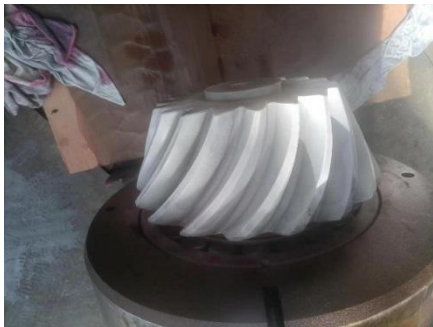
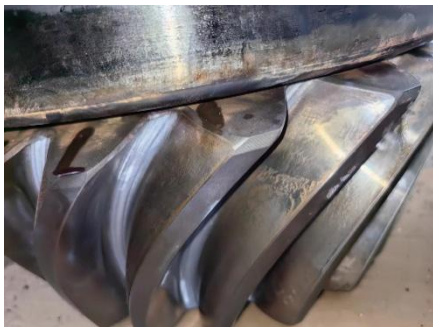
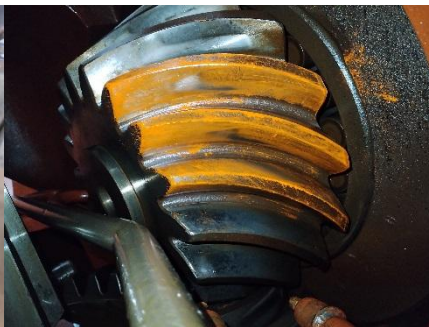
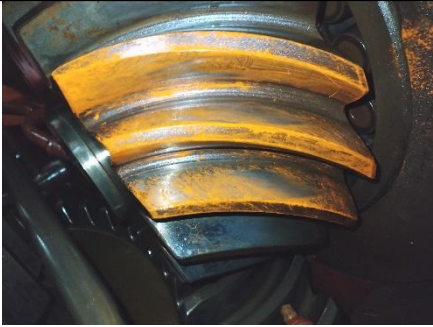
100-Bevel gear shafts

Normal Wear

PT (Penetrant Testing) indicates no cracks.

Suboptimal meshing position, but tooth clearance is normal.

Surface rust, black spots on the tooth surfaces.

Continue usage.

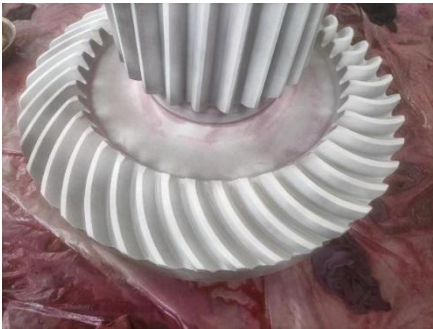
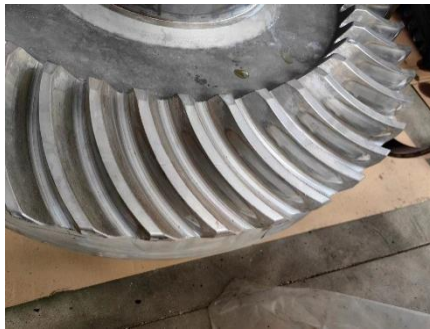
502-Bevel gear

- Normal Wear
- PT Testing shows no cracks.
- Surface rust, black spots on the tooth surfaces.
- Continue usage.

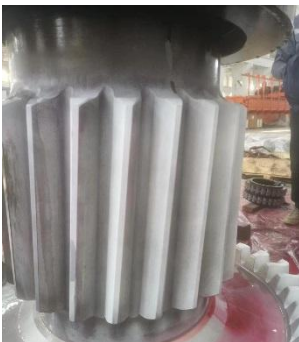
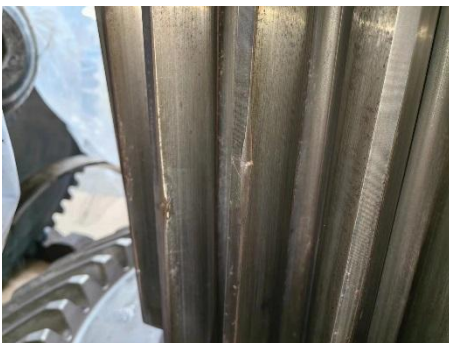
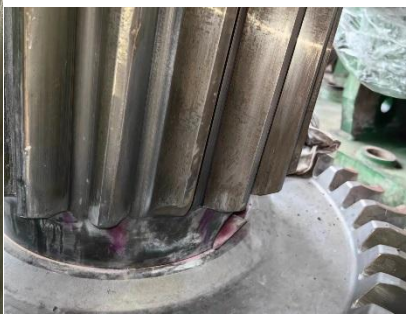
500- Tooth Shaft

- Evidence of prior grinding on one tooth.
- Evidence of prior grinding on five tooth surfaces.
- PT Testing shows no cracks.
- Surface rust, black spots on the tooth surfaces.
- Continue usage.

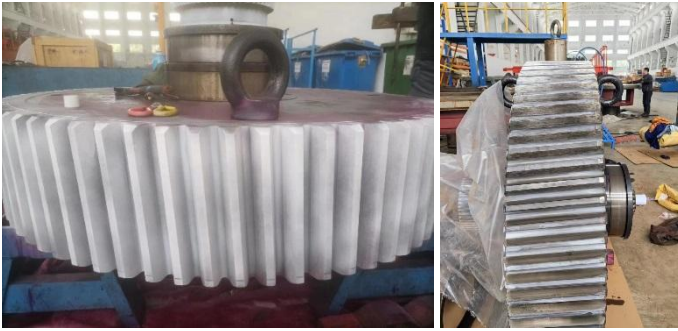
402-Gear

- Slight wear on tooth surfaces.
- Surface rust, black spots on the tooth surfaces.
- PT Testing shows no cracks.
- Continue usage.

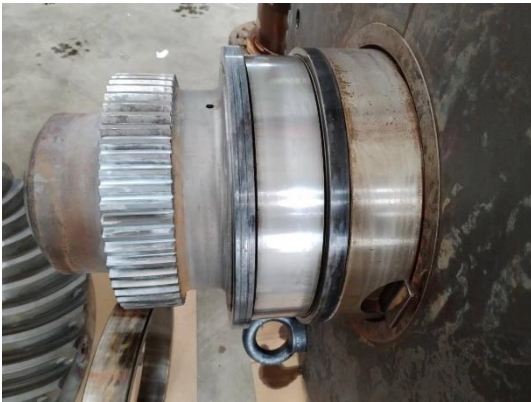
400-Shaft

- Slight impact wear at the keyway.
- Surface rust.
- PT Testing shows no cracks.
- Continue usage.

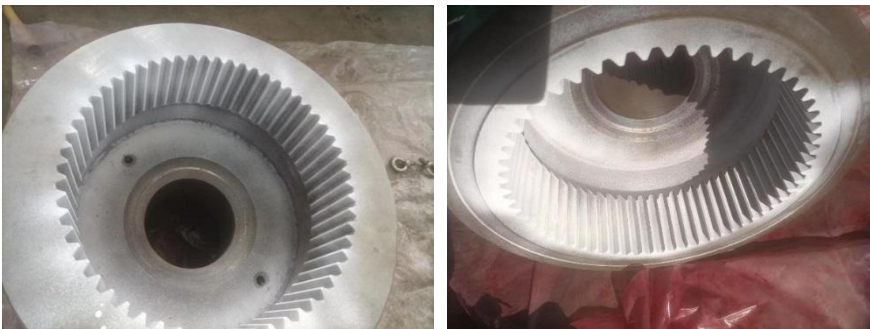
390- Gear Sleeve

- Slight impact wear at the keyway.
- Surface rust, black spots on the tooth surfaces.
- PT Testing shows no cracks.
- Continue usage.

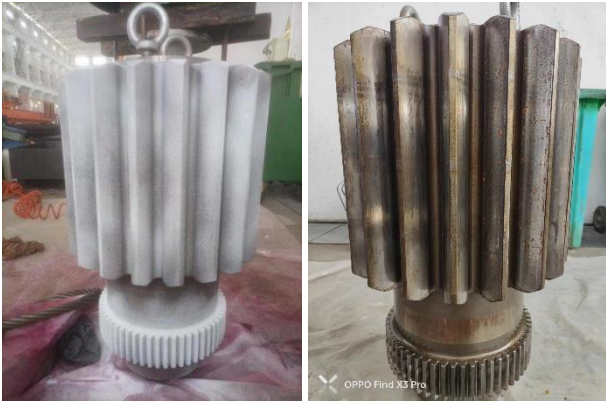
301- Sun Gear

- Slight wear on tooth surfaces.
- Surface rust, black spots on the tooth surfaces.
- PT Testing shows no cracks.
- Continue usage.

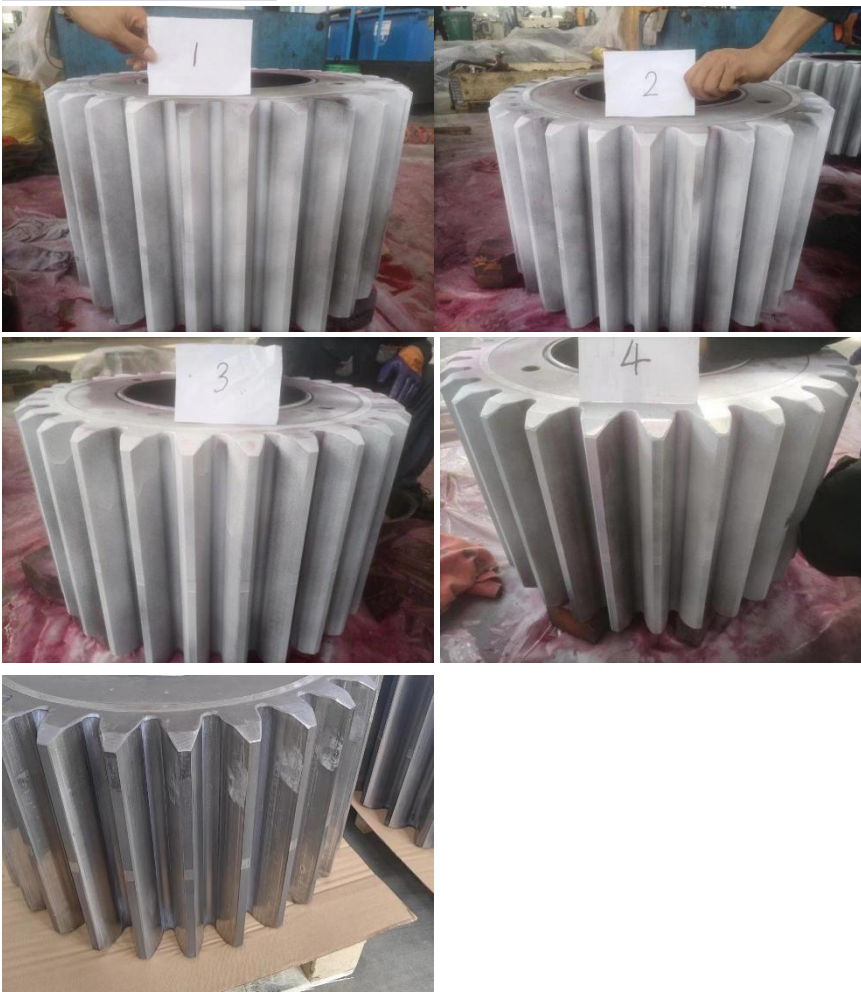
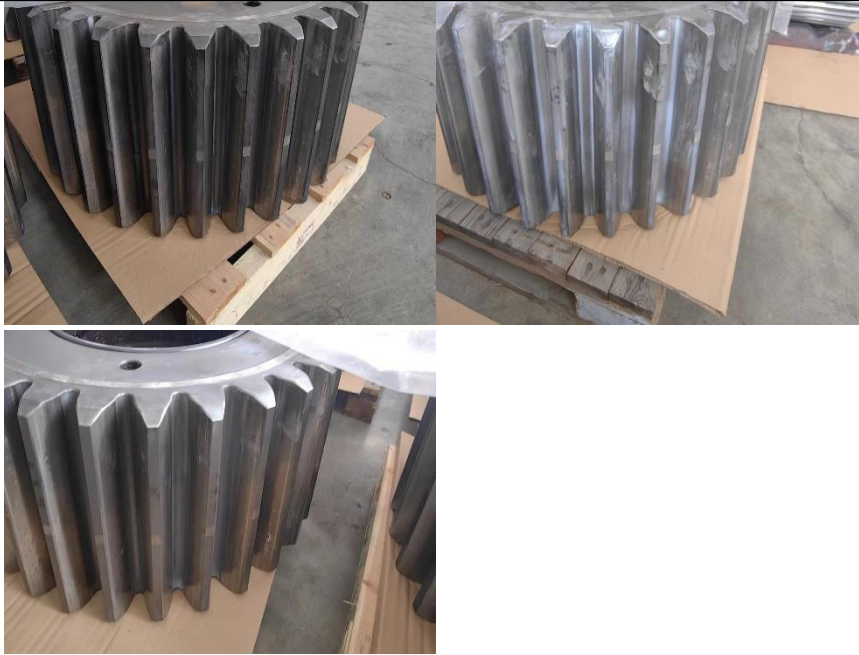
302- Planetary Gear

- Multiple tooth surfaces show signs of repair.
- Surface rust, black spots on the tooth surfaces.
- PT Testing shows no cracks.
- Due to incomplete disassembly of the planetary gear bearing (position 350), it is not possible to determine if the inner bore of the planetary gear is worn. Pending confirmation from the buyer, the assessment of whether the inner bore of the planetary gear is repaired will be done later.

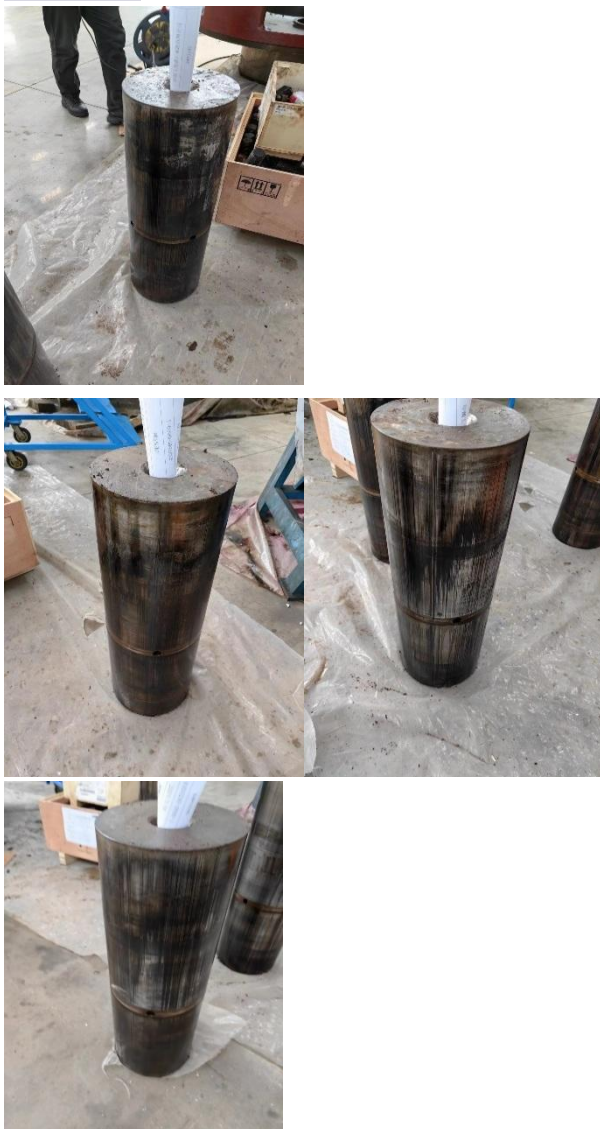
300-Shaft

- Surface rust.
- Axial pull marks.
- After manual grinding, continue usage.
- Grinding process for axial pull marks: Grinding high points with an angle grinder.

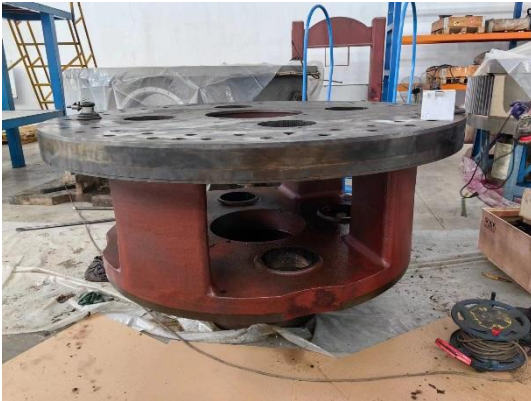
200- Planetary Carrier

- Surface rust.
- After rust removal, continue usage.

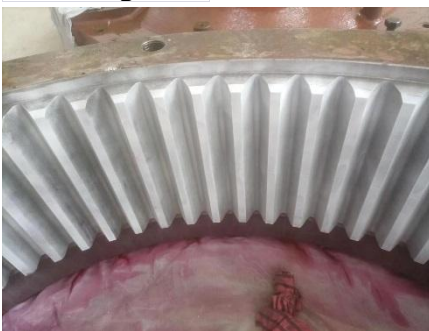
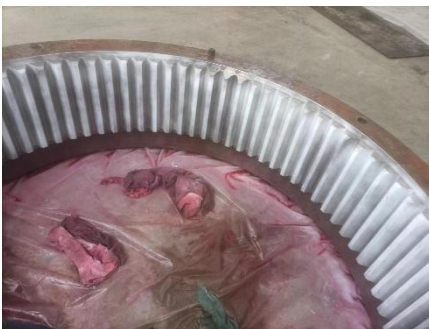
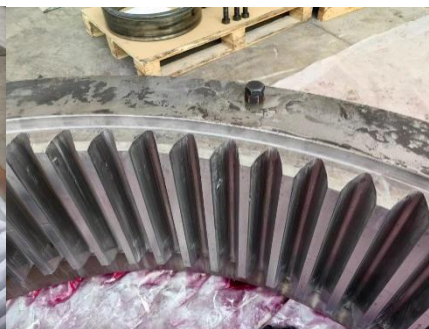
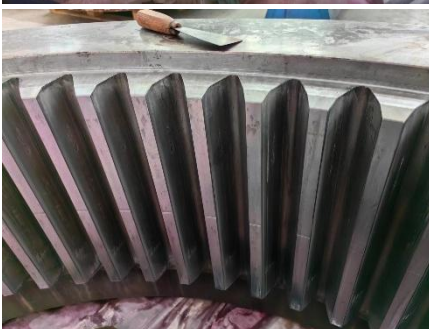
202- Ring Gear

- Six teeth have impact damage.
- PT Testing shows no cracks.
- Surface rust, black spots on the tooth surfaces.
- After manual grinding, continue usage.
- Repair process: Grinding high points using an angle grinder.

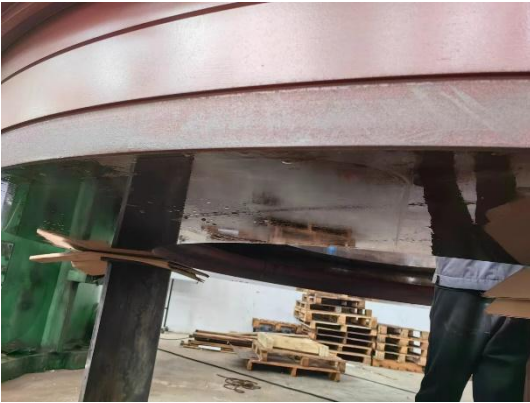
290- Output Flange

- Surface rust on the output flange mirror, with scratches.
- After manual grinding, continue usage.
- Grinding process: Polishing rusted areas to brightness using 600-1000# sandpaper.

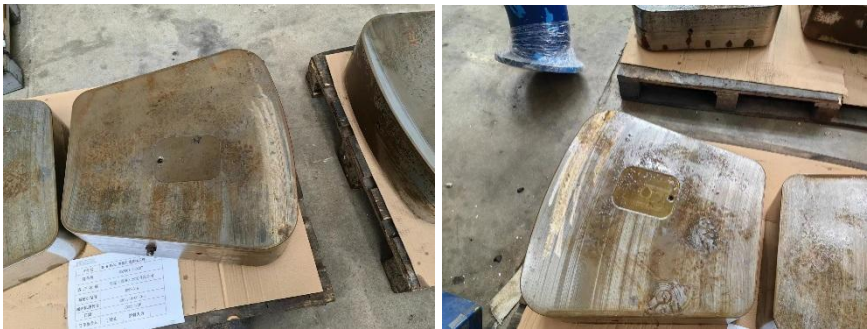
253 Thrust Pad

- Foreign object entry, deep scratches on the surface.
- Surface layer of Babbitt alloy peeling.
- Surface scratches have signs of repair.
- Repair required.
- Repair process: Pouring Babbitt alloy, grinding, and fitting.

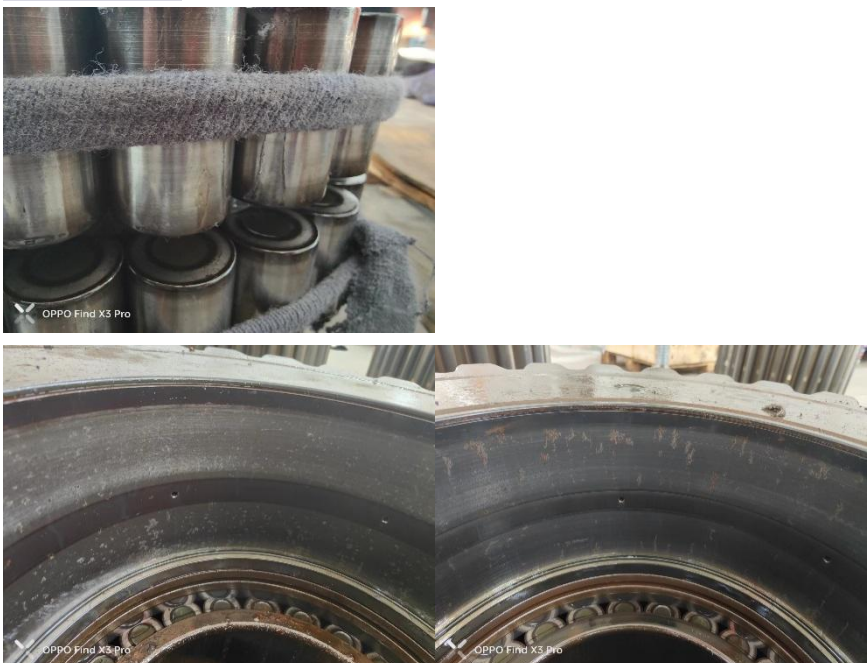
350- Bearing

- Rust corrosion.
- Peeling.
- Foreign object entry.
- Replacement required.

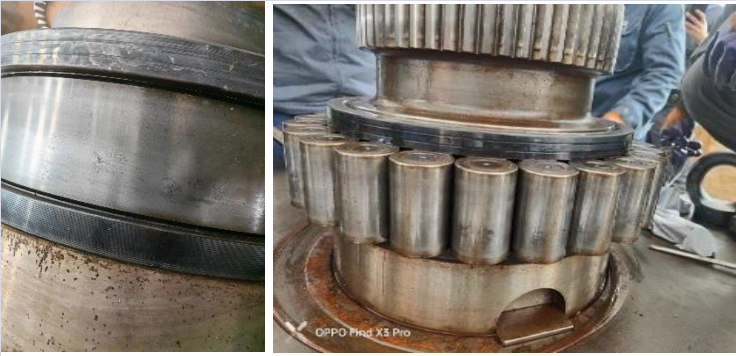
<p>450- Bearing</p>

<p>Fault Type:</p> <ul style="list-style-type: none">• Rust corrosion.• Replacement required.
<p>451- Bearing</p>

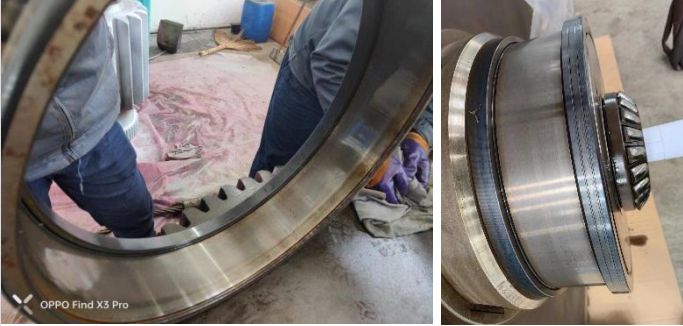
<p>Fault Type:</p> <ul style="list-style-type: none">• Rust corrosion.• Foreign object entry.• Replacement required.
<p>452- Bearing</p>

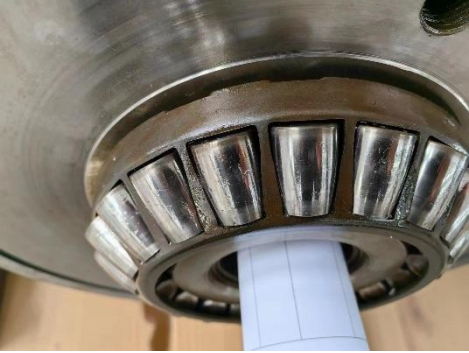
<p>Fault Type:</p> <ul style="list-style-type: none">• Foreign object entry.• Replacement required.
<p>550- Bearing</p>

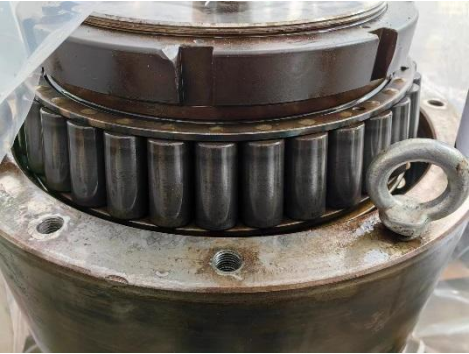
<p>Fault Type:</p> <ul style="list-style-type: none">• Rust corrosion.• Replacement required.

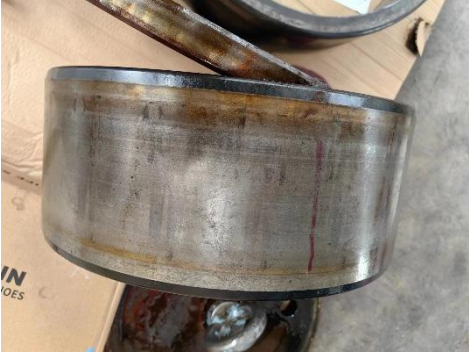
<p>551- Bearing</p>

<p>Fault Type:</p> <ul style="list-style-type: none">• Rust corrosion.• Foreign object entry.• Replacement required.
--	---

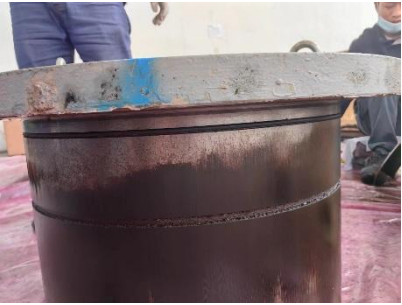
<p>124- O-ring</p>

<p>Fault Type:</p> <ul style="list-style-type: none">• Aging of the O-ring.• Replacement required.
<p>127- Spring</p>

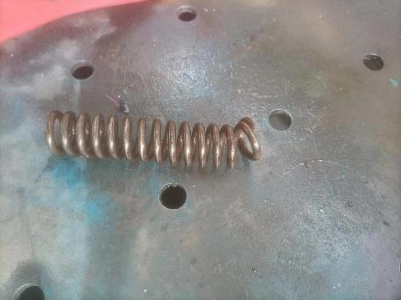
<p>Fault Type:</p> <ul style="list-style-type: none">• Deformation of one spring.• Replacement required.
<p>128- Adjustment Pad</p>

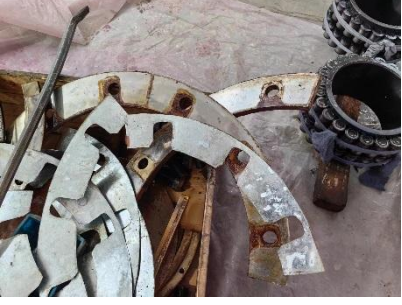
<p>Fault Type:</p> <ul style="list-style-type: none">• Adjustment usage.• Replacement required.
<p>132- O-ring</p>

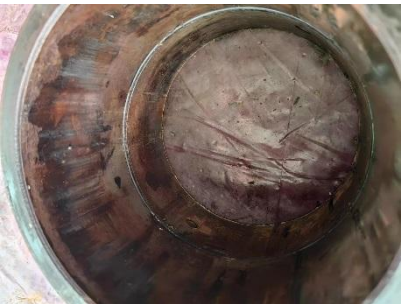
<p>Fault Type:</p> <ul style="list-style-type: none">• Aging of the O-ring.• Replacement required.

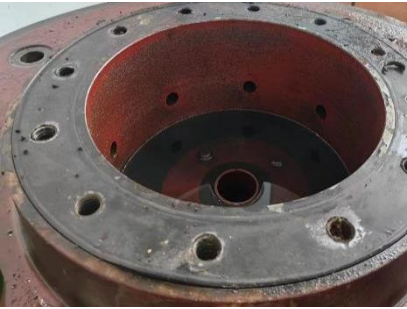
<p>284- O-ring</p>

<p>Fault Type:</p> <ul style="list-style-type: none">• Aging of the O-ring.• Replacement required.
<p>286- O-ring</p>

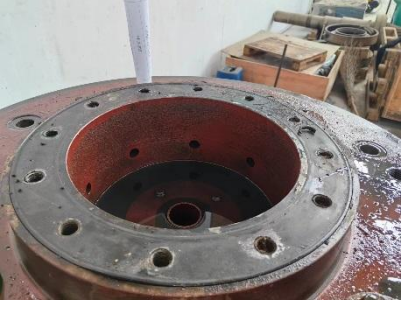
<p>Fault Type:</p> <ul style="list-style-type: none">• Aging of the O-ring.• Replacement required.
<p>289-O O-ring</p>

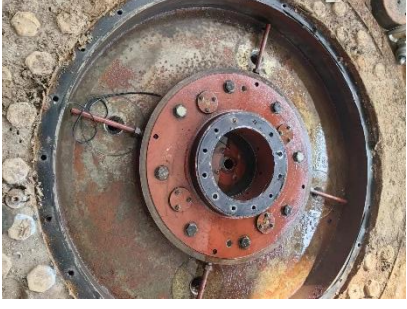
<p>Fault Type:</p> <ul style="list-style-type: none">• Aging of the O-ring.• Replacement required.
<p>288- Bolt</p>

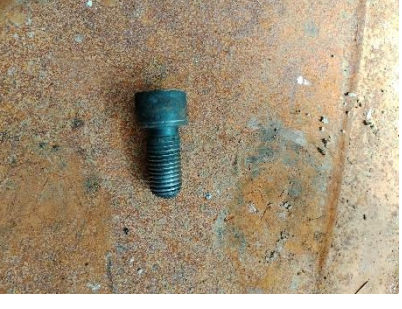
<p>Fault Type:</p> <ul style="list-style-type: none">• Bolt sliding.• Replacement required.

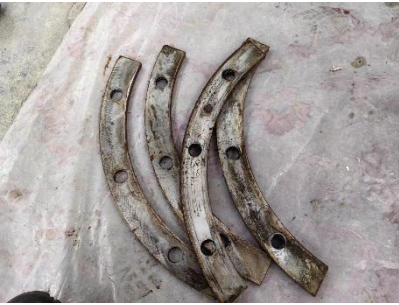
<p>528- Adjustment Pad</p>

<p>Fault Type:</p> <ul style="list-style-type: none"> • Adjustment usage. • Replacement required.
<p>Check Valve</p>

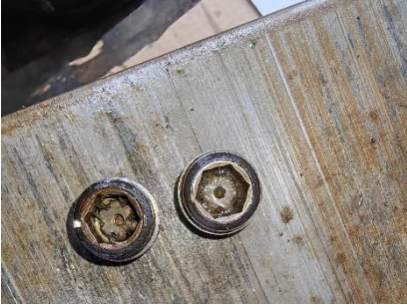
<p>Fault Type:</p> <ul style="list-style-type: none"> • Check valve blockage. • Replacement required.
<p>Oil Window</p>

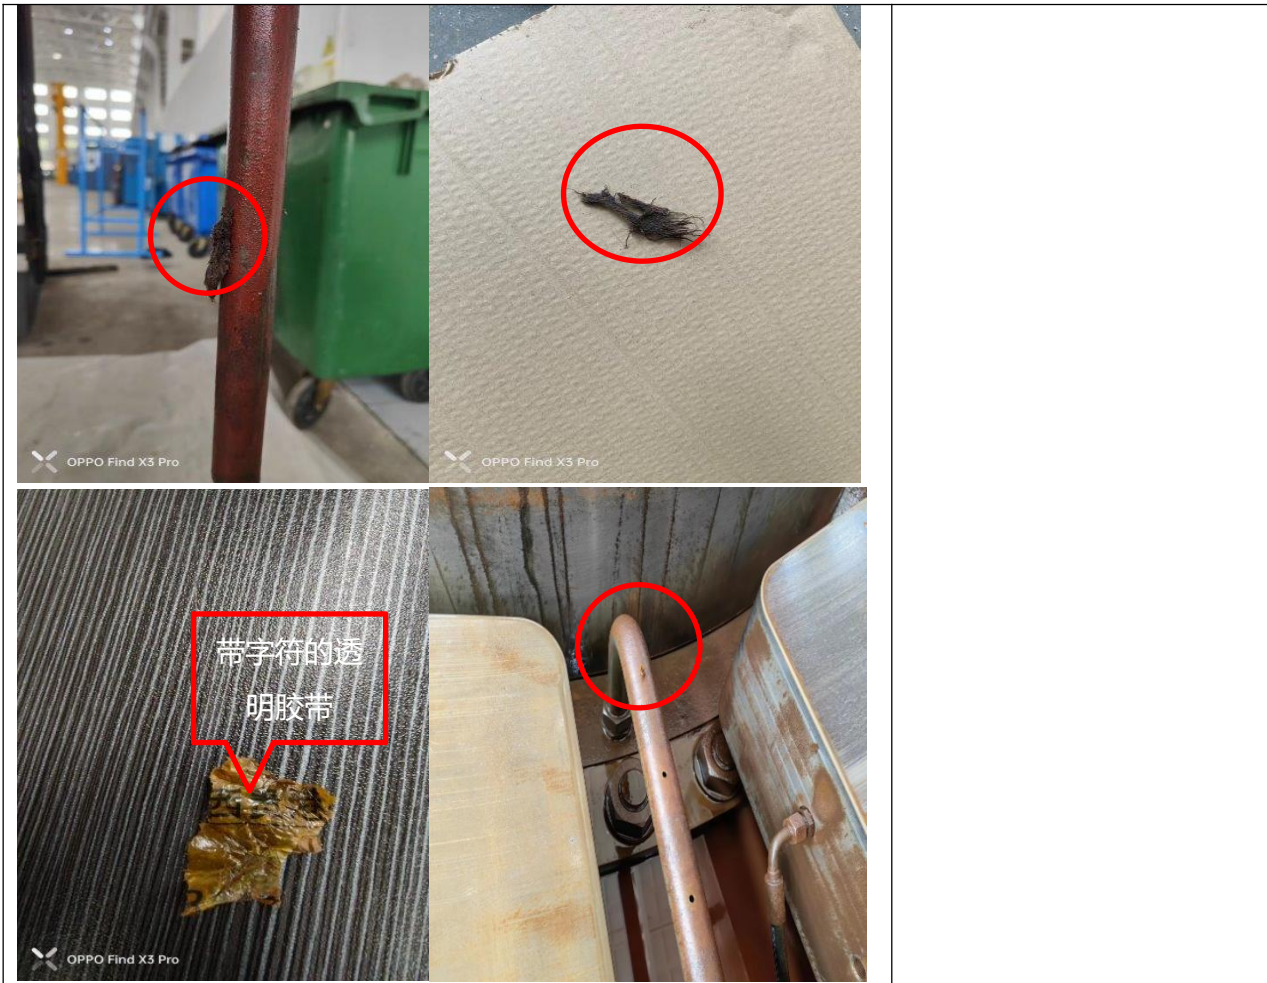
<p>Fault Type:</p> <ul style="list-style-type: none"> • Missing oil window. • Replacement required.
<p>Thrust Pad Spray Lubrication:</p>	<p>Fault Type:</p> <ul style="list-style-type: none"> • Multiple blockages in the oil pipe. • Debris identified as cotton or transparent tape. • After cleaning, continue usage.
