Site Inspection Report – Chemical Industry

Customer:	Fude Energy New Materials Co., Ltd.
Contact person:	Lu Hongwei
Service Scope:	Replace bearings
Service Date:	December 6, 2021
Executive Engineer:	Zhao Jie
Whether First-time Service:	Yes
Customer Order Number:	WS21246S31130
Gearbox Model:	316F-311 ; S/N: 4587716-0020-1
The Report Contains:	Total 16 Pages

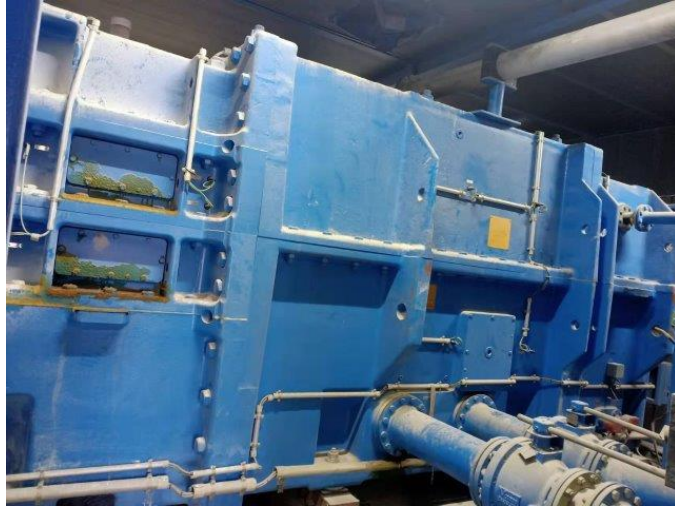
Fig. 1

Appearance normal
Oil Leakage of Output Shaft
Oil Leakage on End Cover

Spectrum report from customer
indicates several bearings are abnormal

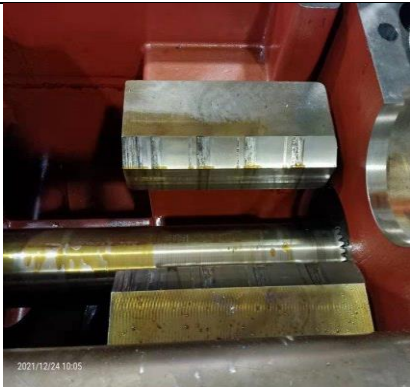
<p>2021/12/24 10:05</p>	<p>Fault type:</p> <p>Slight wear on the bearings</p>
<p>204 gear</p> <div>

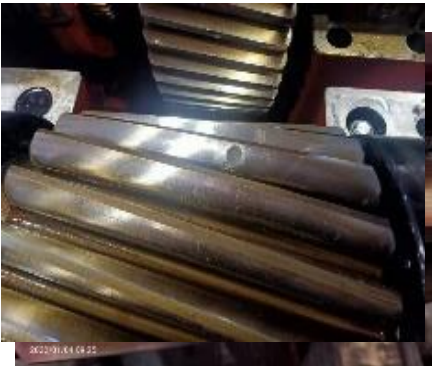
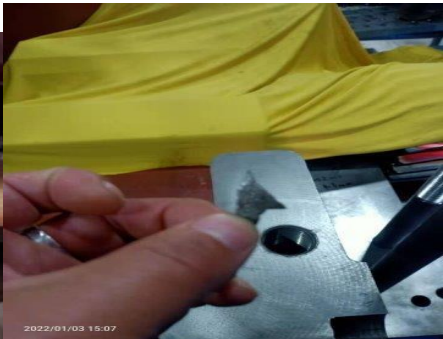
- Gear/Gear Shaft: 204 gear has peeling points on three tooth surfaces; the 405 gear tooth surface, meshed with the 204 gear, shows slight signs of wear; the erosion width on 589 bearing position (500 shaft) is 80mm; diameter after wear is approximately 4 mm smaller than original size; 350 bearing position has rotary wear.
- For 150 four-point contact bearing, one area of the inner roller is peeled off, about 1 mm*2.5mm, and the rest of the bearings wear normally.
- Accessories and others: spacer rings 525/526 for high and low speed gear end have concave wear, and the 630 clutch hose is distorted and deformed by external forces.

<p>2022/01/03 15:07</p> </div>	<p>Fault type:</p> <p>Peeling off at three locations on the tooth surface</p> <p>Repair and open diversion channel</p>

Replace all bearings of the reducer, measure and adjust installation according to original parameter. Bearing position of 500 shaft has been repaired by laser cladding; start installation when PT test shows that there are no cracks. All worn spacer rings are replaced. Adjust the output shaft and make new spring sleeve. Grind the peeling surface of the 204 gear and check with PT if there is crack. Grind and repair high points of the tooth surface on 405 gear, and assembly according to the original standards.

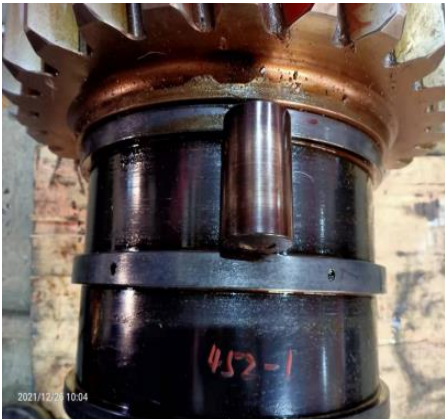
<p>452- Bearing</p>

<p>Bearing Type: 185056 SL XL C3 BR</p> <p>Fault Type: Normal wear, no abnormalities found</p>
---	--
